Manhole Inspection Summary

Manhole # S350__076MH

Location Address: **side 14 e montgomery st**

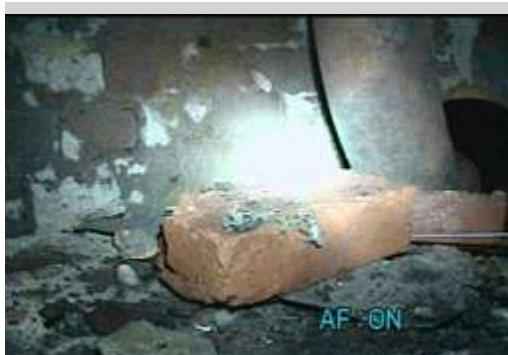
Misc

Condition: ☐ Sound ☐ Cracked ☐ Root Intrusion ☐ Deteriorated ☐ Leaks ☒ **Debris**

channel debris

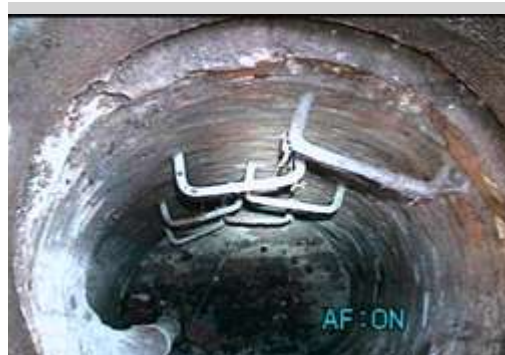
Defect 2

Count: **6** Missing: **0** ☒ **Corroded**

corr steps

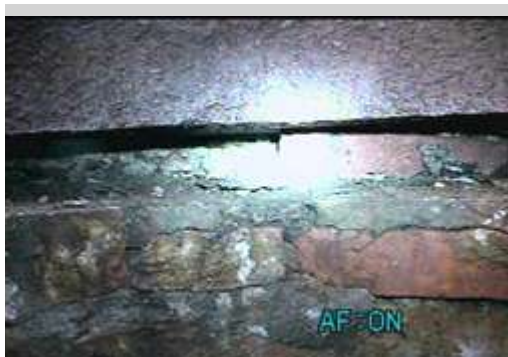
Defect 1

Condition: ☐ Sound ☐ Cracked ☐ Root Intrusion ☒ **Loose Brick** ☒ **Deteriorated**

loose bricks, deteriorated

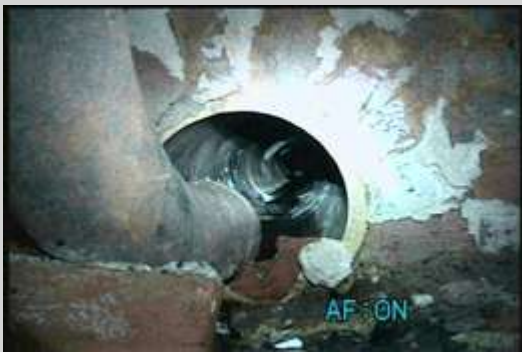
12 O'Clock Outflow

8 in. Circular Gravity Sewer
Pipe Out @ 12 O'Clock

Pipe Material: **Clay** ☐ Pipe Lined

Invert Depth: **9.25** (ft.) Flow Characteristics: **None**

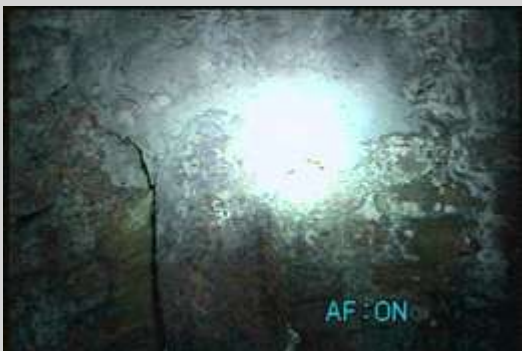
11 O'Clock Inflow

8 in. Circular Gravity Sewer
Pipe In @ 11 O'Clock

Pipe Material: **Unknown** ☐ Pipe Lined

Invert Depth: **3.00** (ft.) Flow Characteristics: **None**
